# Snare-Assisted Aortic Valve Crossing: a Case Report

**Citation:** André Grazina, Bárbara L. Teixeira, Luís A. Morais, António Fiarresga and Ruben Ramos et al., (2024), Snare-Assisted Aortic Valve Crossing: a Case Report, *International Journal of Cardiovascular Medicine*, 3(1); DOI:10.31579/2834-796X/053

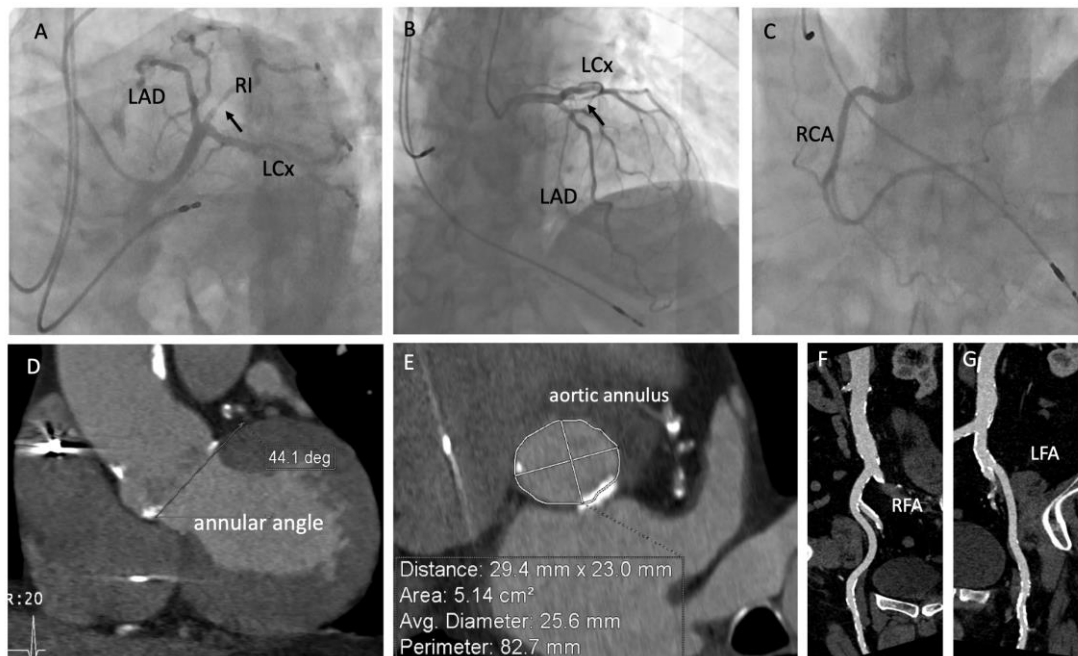
**Figure 1.** Coronary angiogram (images A-C) and pre-procedural CTA (images D-G). Left coronary artery (images A and B) and right coronary artery (image C) showing an obstructive lesion in the proximal ramus intermedius (arrow). (LAD – left descending artery; LCx – left circumflex artery; RI – ramus intermedius; RCA – right coronary artery; RFA – right femoral artery; LFA – left femoral artery)

Pre-procedural cardiac computed tomography angiography (CTA) for TAVI planning (figure 1 D-G) shows a tricuspid aortic valve, with severe calcification, AV calcium score of 3560 units and marked calcification in the commissures next to the non-coronary cusp, mean annular diameter of 25.6mm and annular angle of 44°. Coronary ostia were high (16mm for left main coronary artery and 14mm for right coronary artery), with very low risk for coronary obstruction. Ilio-femoral axis evaluation showed good luminal diameters (right femoral artery 7.1x9.5mm, left femoral artery 7.3x8.9mm), moderate non-circumferential calcification, and no significant tortuosity.

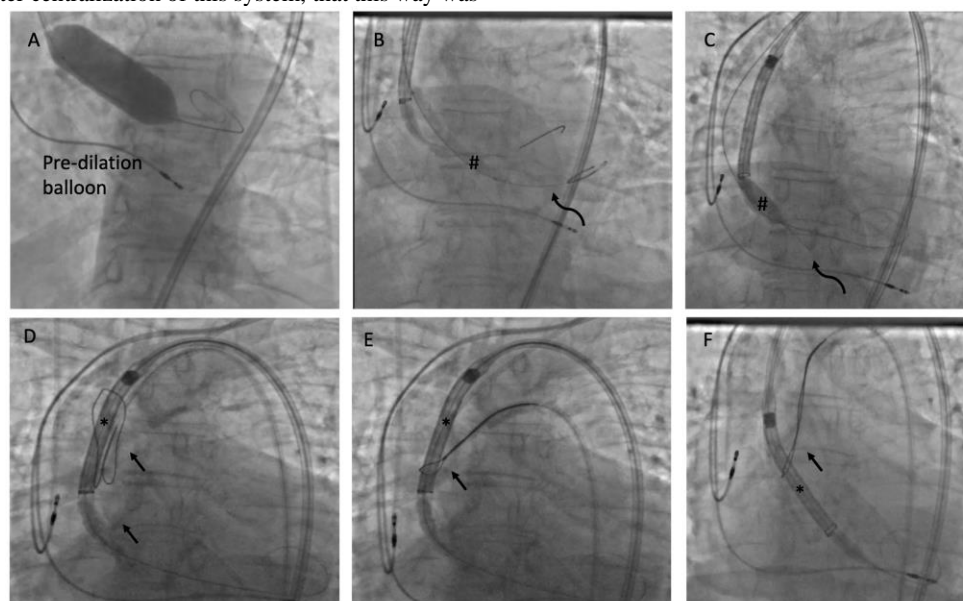
**Figure 2.** Fluoroscopic images of pre-dilation (image A) and buddy-wire (curved arrows) and buddy-balloon (number sign) techniques with unsuccessful aortic valve crossing (images B and C). Snare technique (images C-E) with placement of snare (arrows) around the valve delivery system (asterisks) through the left femoral artery to perform a pulling movement and centralize the valve (image E) allowing the native valve crossing (image F).

Through the right femoral artery, a pre-dilation was made using a 20mm size balloon (figure 2A), followed by unsuccessful attempt to cross the valve delivery system of Corevalve Evolut Pro 29mm (Medtronic) through the native aortic valve. After, it was attempted to perform buddy-wire and buddy-balloon techniques (figure 2B and C), in order to fill the external commissure (between the non-coronary and right coronary cusps), allowing centralization and better alignment of the valve delivery system, also unsuccessfully.

Through the left femoral artery, a snare was placed around the valve delivery system, pulling it to a better centralization of this system, that this way was

able to cross the native calcified aortic valve. This technique is shown in figure 2 D-F. The valve was after delivered without complications and post-dilated with a 24mm size balloon (figure 3), with good final result and no paravalvular regurgitation. No complications occurred during the hospitalization, the post-procedural transthoracic echocardiogram showed a well-functioning prosthetic valve, without paravalvular leak and the patient was discharged at the third day. At 6 months of follow-up, the patient was clinically improved, at NYHA functional class I.

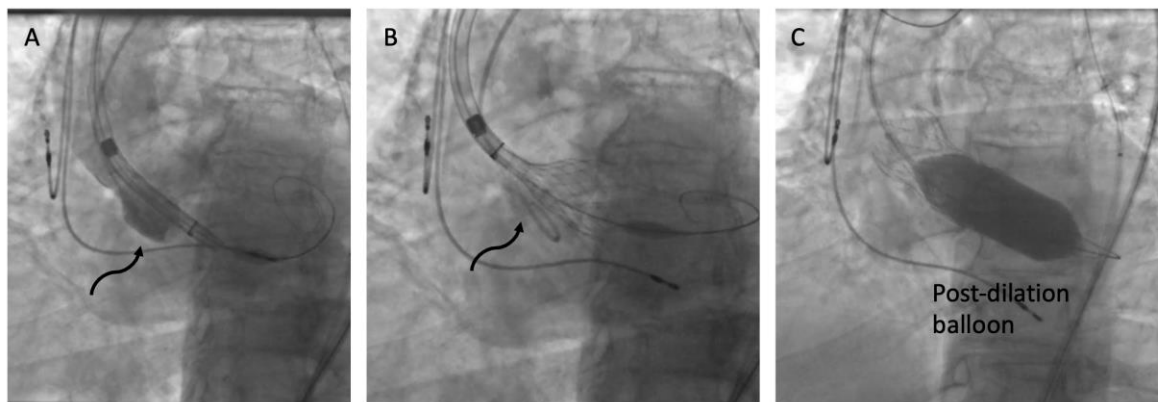
**Figure 3.** Positioning and release of the valve Corevalve Evolut Pro 29mm (curved arrows) in images A and B, post-dilated with a 24mm balloon (image C).
